NACE International Corrosion 2007 Conference & Expo March 11-15, 2007, Nashville, Tennessee

NACE2007-07139

METHODOLOGY FOR ASSESSING THE EFFECTS OF PLAIN DENTS, WRINKLE BENDS, AND MECHANICAL DAMAGE ON PIPELINE INTEGRITY

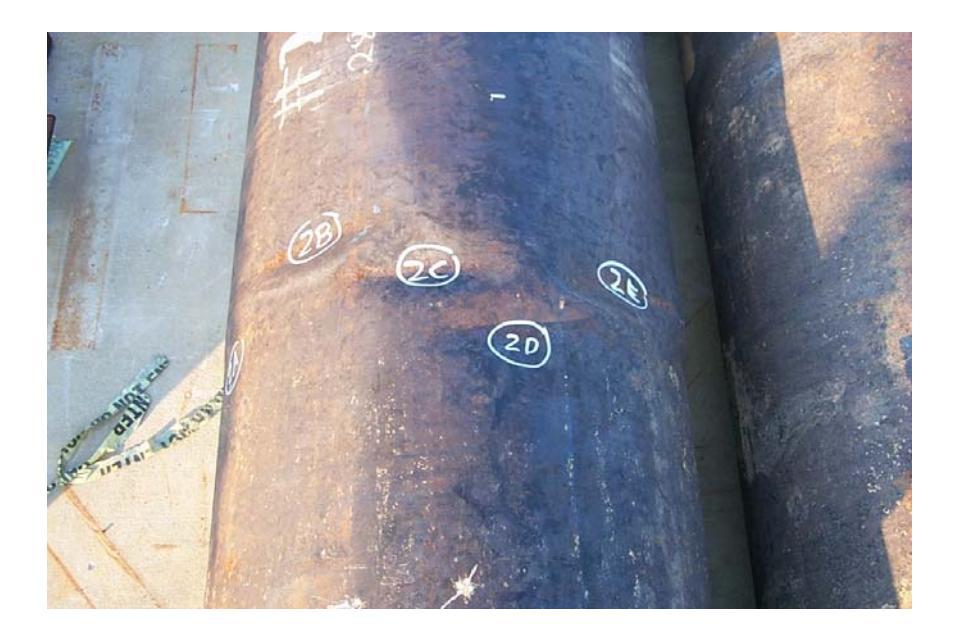
Figure 1 – Photo of 36-inch diameter pipe with 2% wrinkles

- 2 percent wrinkle NO failure after 44,541 cycles
- 4 percent wrinkle failure after 2,791 cycles
- 6 percent wrinkle failure after 1,086 cycles

The above results were a significant find for the API research program. The critical observations is that although depth of damage is important (wrinkle or dent), the more important factor is the profile shape of the damage. The change in radius of curvature along the length of the line is directly related to bending strains. As noted in the fatigue data, a wrinkle having a depth of 6% poses a significant threat to the integrity of the pipeline. Although intentional wrinkle bends are unlikely to occur offshore, the authors have observed several anchor impact zones that clearly resembled the damage profile associated with wrinkle bends. For this reason, any offshore damage that resembles a wrinkle bend (i.e. deect having a sharp curvature) should be removed as soon as is prudent.

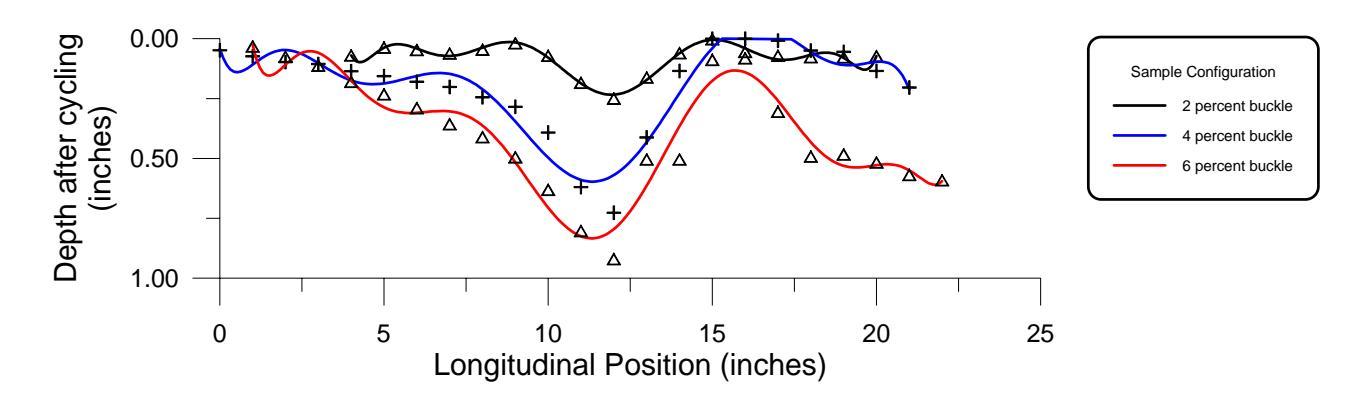
PROFILE MEASUREMENTS OF WRINKLES AFTER COMPLETION OF APPLIED CYCLES

Figure 2 – Wrinkle profile for the three test samples

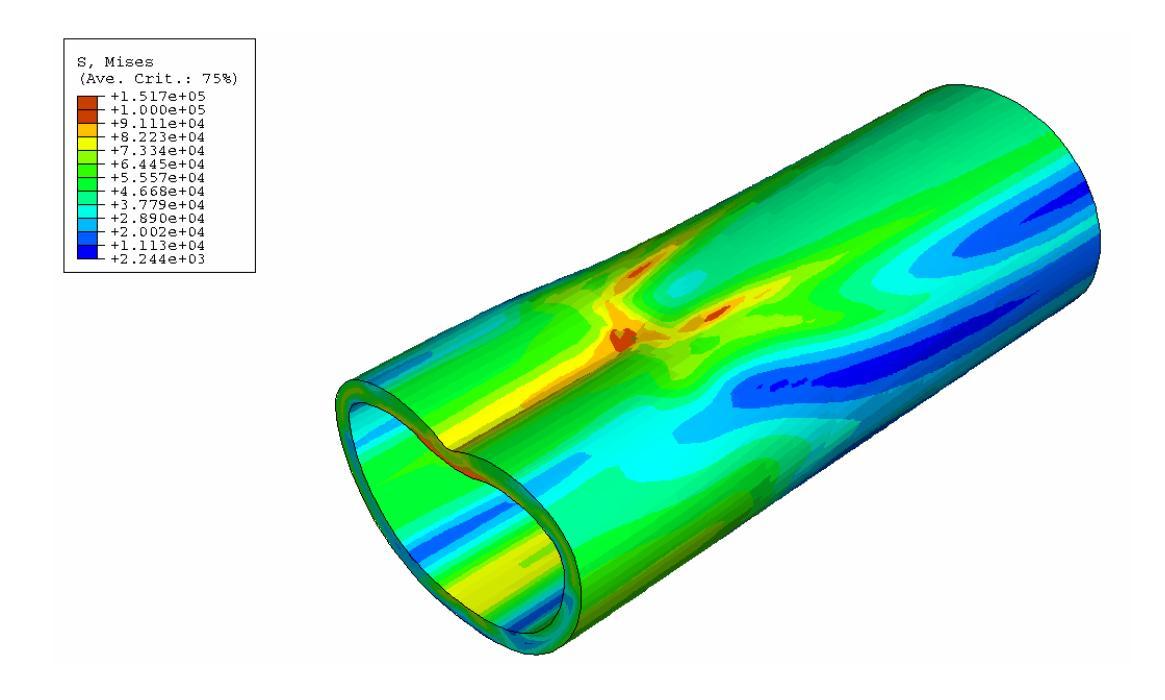
Figure 3 - Von Mises stress after internal pressure removed (residual stress state) (Magnification factor on displacement of 2.4)

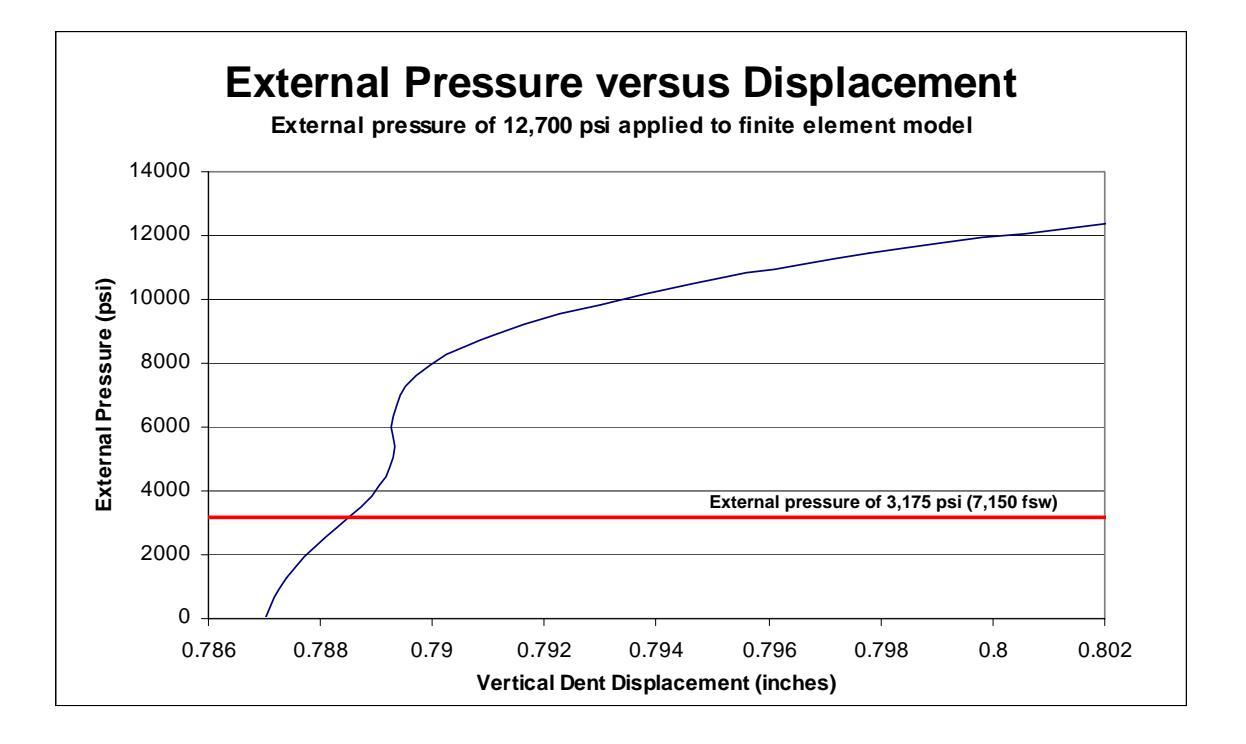
Figure 4 - Response of dented pipe to elevated external pressures

As discussed previously, the presence of dents in a pipeline likely change the ovality in a pipeline. For subsea applications, especially deepwater conditions where external pressures are large, assessing the effects of collapse should be a part of every dent evaluation. As an example, a presentation is made on prior work that involved a dent in a subsea flowline in the Gulf of Mexico at a water depth of approximately 7,000 feet. While the main purpose of the evaluation was to assess the integrity of the damage from a cyclic service standpoint, considerations were also made to determine the collapse capacity due to external pressure using finite element based limit analysis.

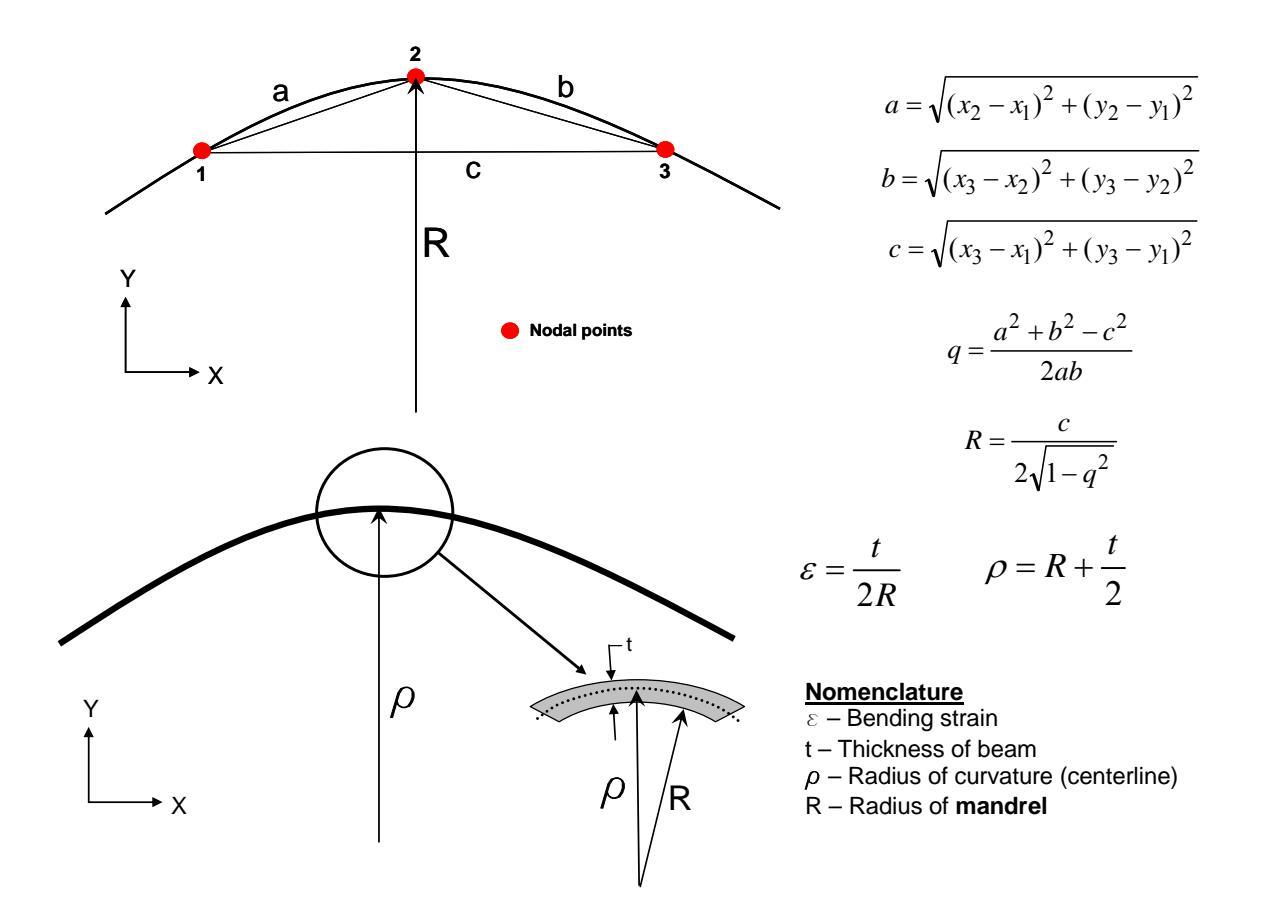
Figure 6 – Calculating bending strain using first principles (*t* in the above formulation is the outer radius of the pipe)

First Principle Bending Strain Calculations. While it is not also possible or practical to construct a detailed finite element model of a damaged pipeline; it is possible to calculate bending strains based on the changing radius of curvature in a laterally displaced pipeline. Using a series of mathematic expressions to calculate radius of curvature, the estimate bending strain is calculated. **Figure 6** provides a schematic showing the method for performing this type of assessment (equations based on law of sin and cosine). The authors highly recommend that this assessment method be performed once displacement data is available. An EXCEL spreadsheet can be programmed to accept the mathematical expressions that will permit the radius of curvature to be calculated as a function of axial position along the length of the line. **Figure 7** is a plot that shows bending strain as a function of axial position along the line.

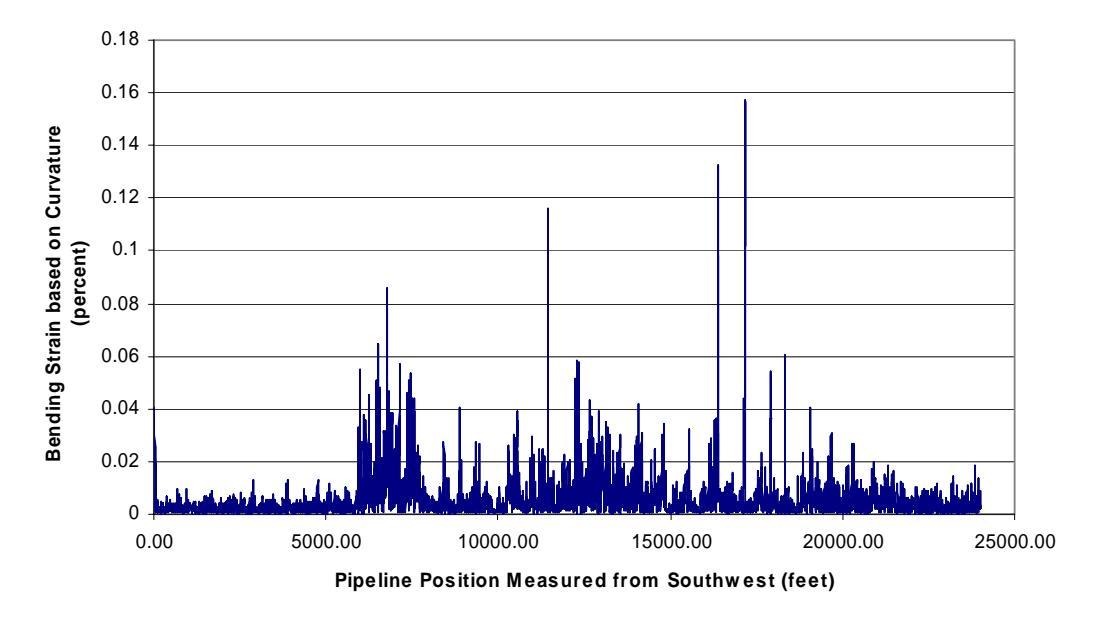
Strain as a Function of Position Along Pipeline

Figure 7 – Bending strain as a function of position calculated using curvature

What is impressive about this approach is that although its accuracy is somewhat limited, it provides an excellent first pass assessment of areas of the pipeline where elevated bending strains are likely to exist. Before any detailed investigations are performed, this method should be used to provide an overall assessment of damage to the pipeline.

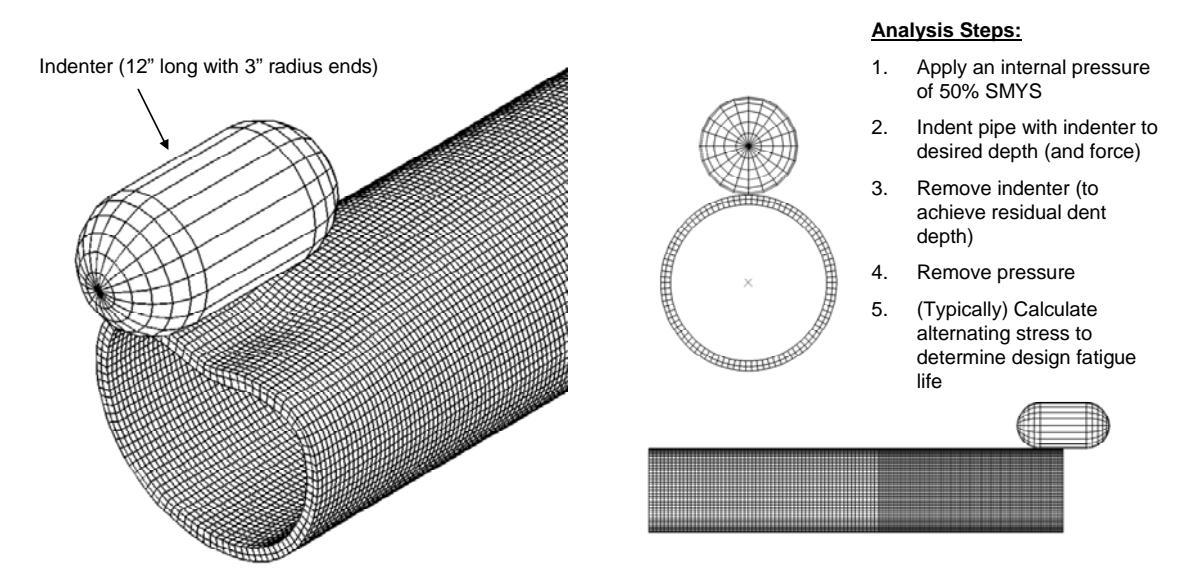
Figure 8 – Methods for assessing dent damage using finite element methods

The greatest level of accuracy is achieved in assessing the severity of dented pipelines when inspection efforts determine the profile of the damaged section of pipe. Once this information is obtained, it is possible to perform a finite element analysis of the damaged area using elastic-plastic material properties to capture the residual stress state of the pipe. Cyclic pressure can be modeled in an effort to estimate the alternating stress in the damaged section of pipe.

Assuming that shakedown to elastic action has occurred between Step #4 and #5 (condition at which no appreciable deformation of the dent is likely with continued pressure cycling), the alternating stress associated with MAOP can be calculated. This value can then be used as input into a fatigue curve to estimate remaining life associated with cyclic service conditions.

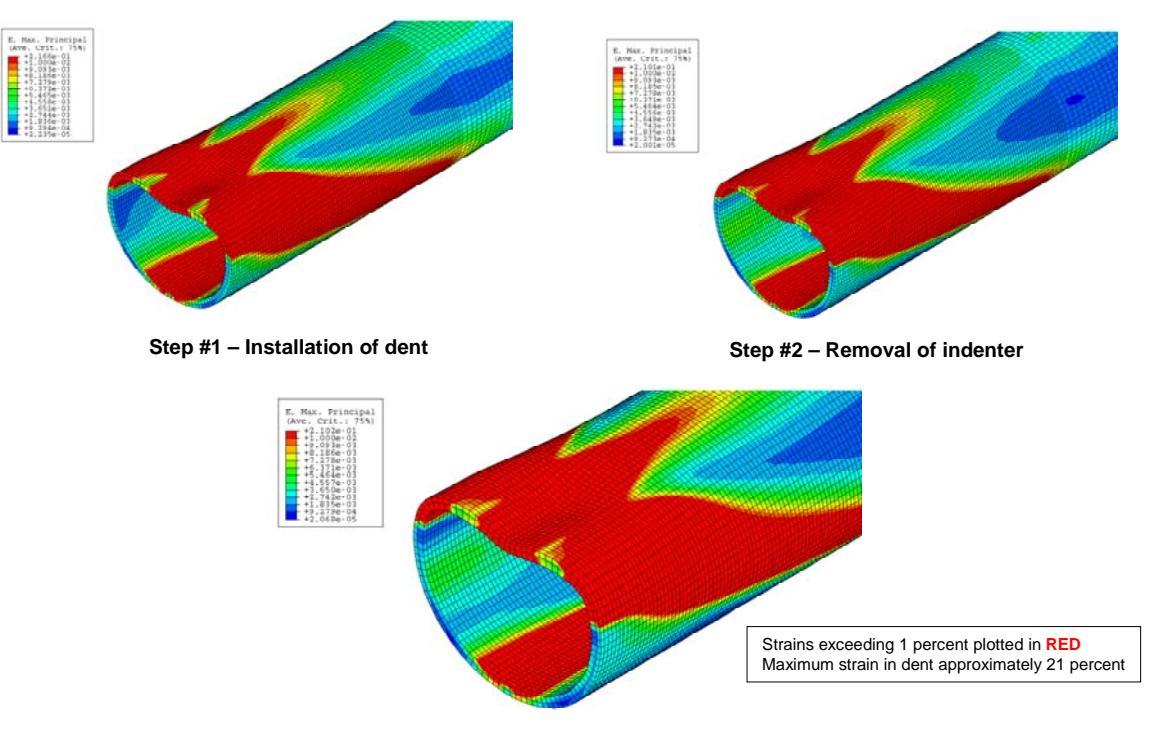
Step #3 - Removal of internal pressure

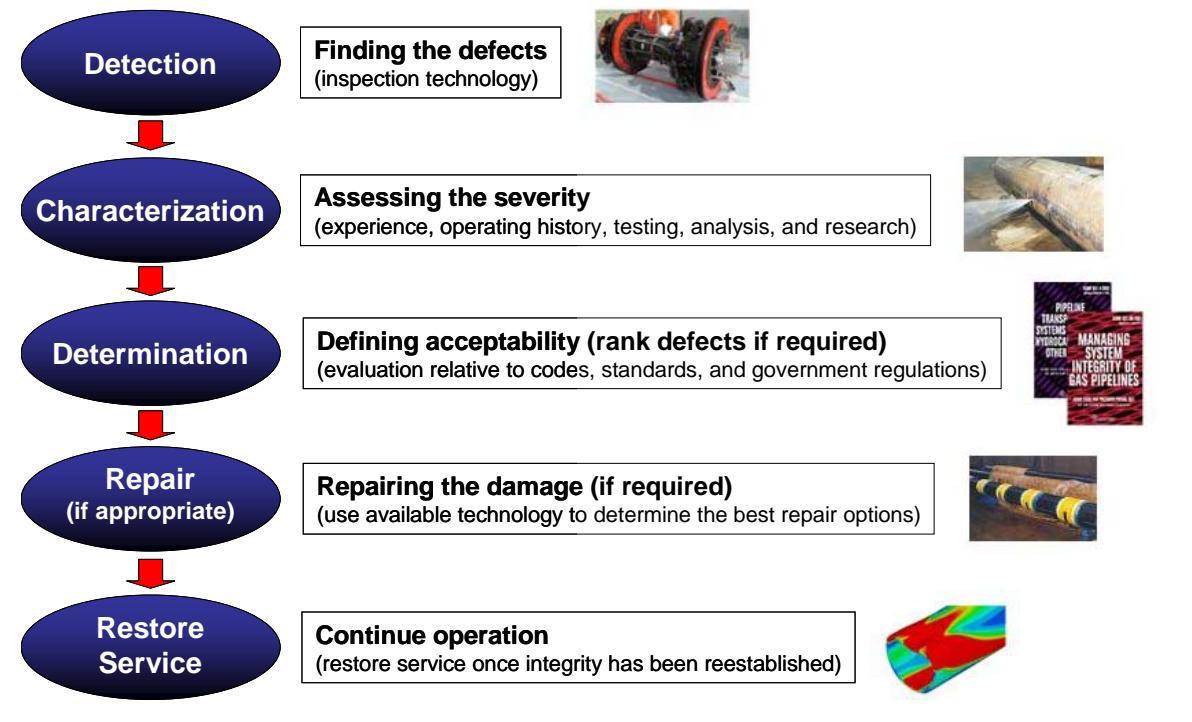
Figure 10 – Steps involved in the defect assessment process

- 1. Detect damaged section of pipe (usually via in-line inspection methods or using a ROV)
- 2. Assess the severity
- 3. Determine acceptability by ranking relative severity if multiple defects exist
- 4. Repair or remove the damaged section of pipeline
- 5. Restore service including hydrotesting required
- 6. Put line back in service and continue operation

By implementing the proposed methods included in this paper, operators can invoke a systematic process for assessing defect severity. Even applying the six step process outlined in **Figure 10** is a good starting point. Another important consideration is that once damage has been detected, operators are encouraged to start collecting and cataloguing information as soon as possible. It has been the authors' observation that when this done, the likelihood for performing a successful damage assessment is greatly increased.
